3H Equine Rehabilitation Stable

New Hill, North Carolina

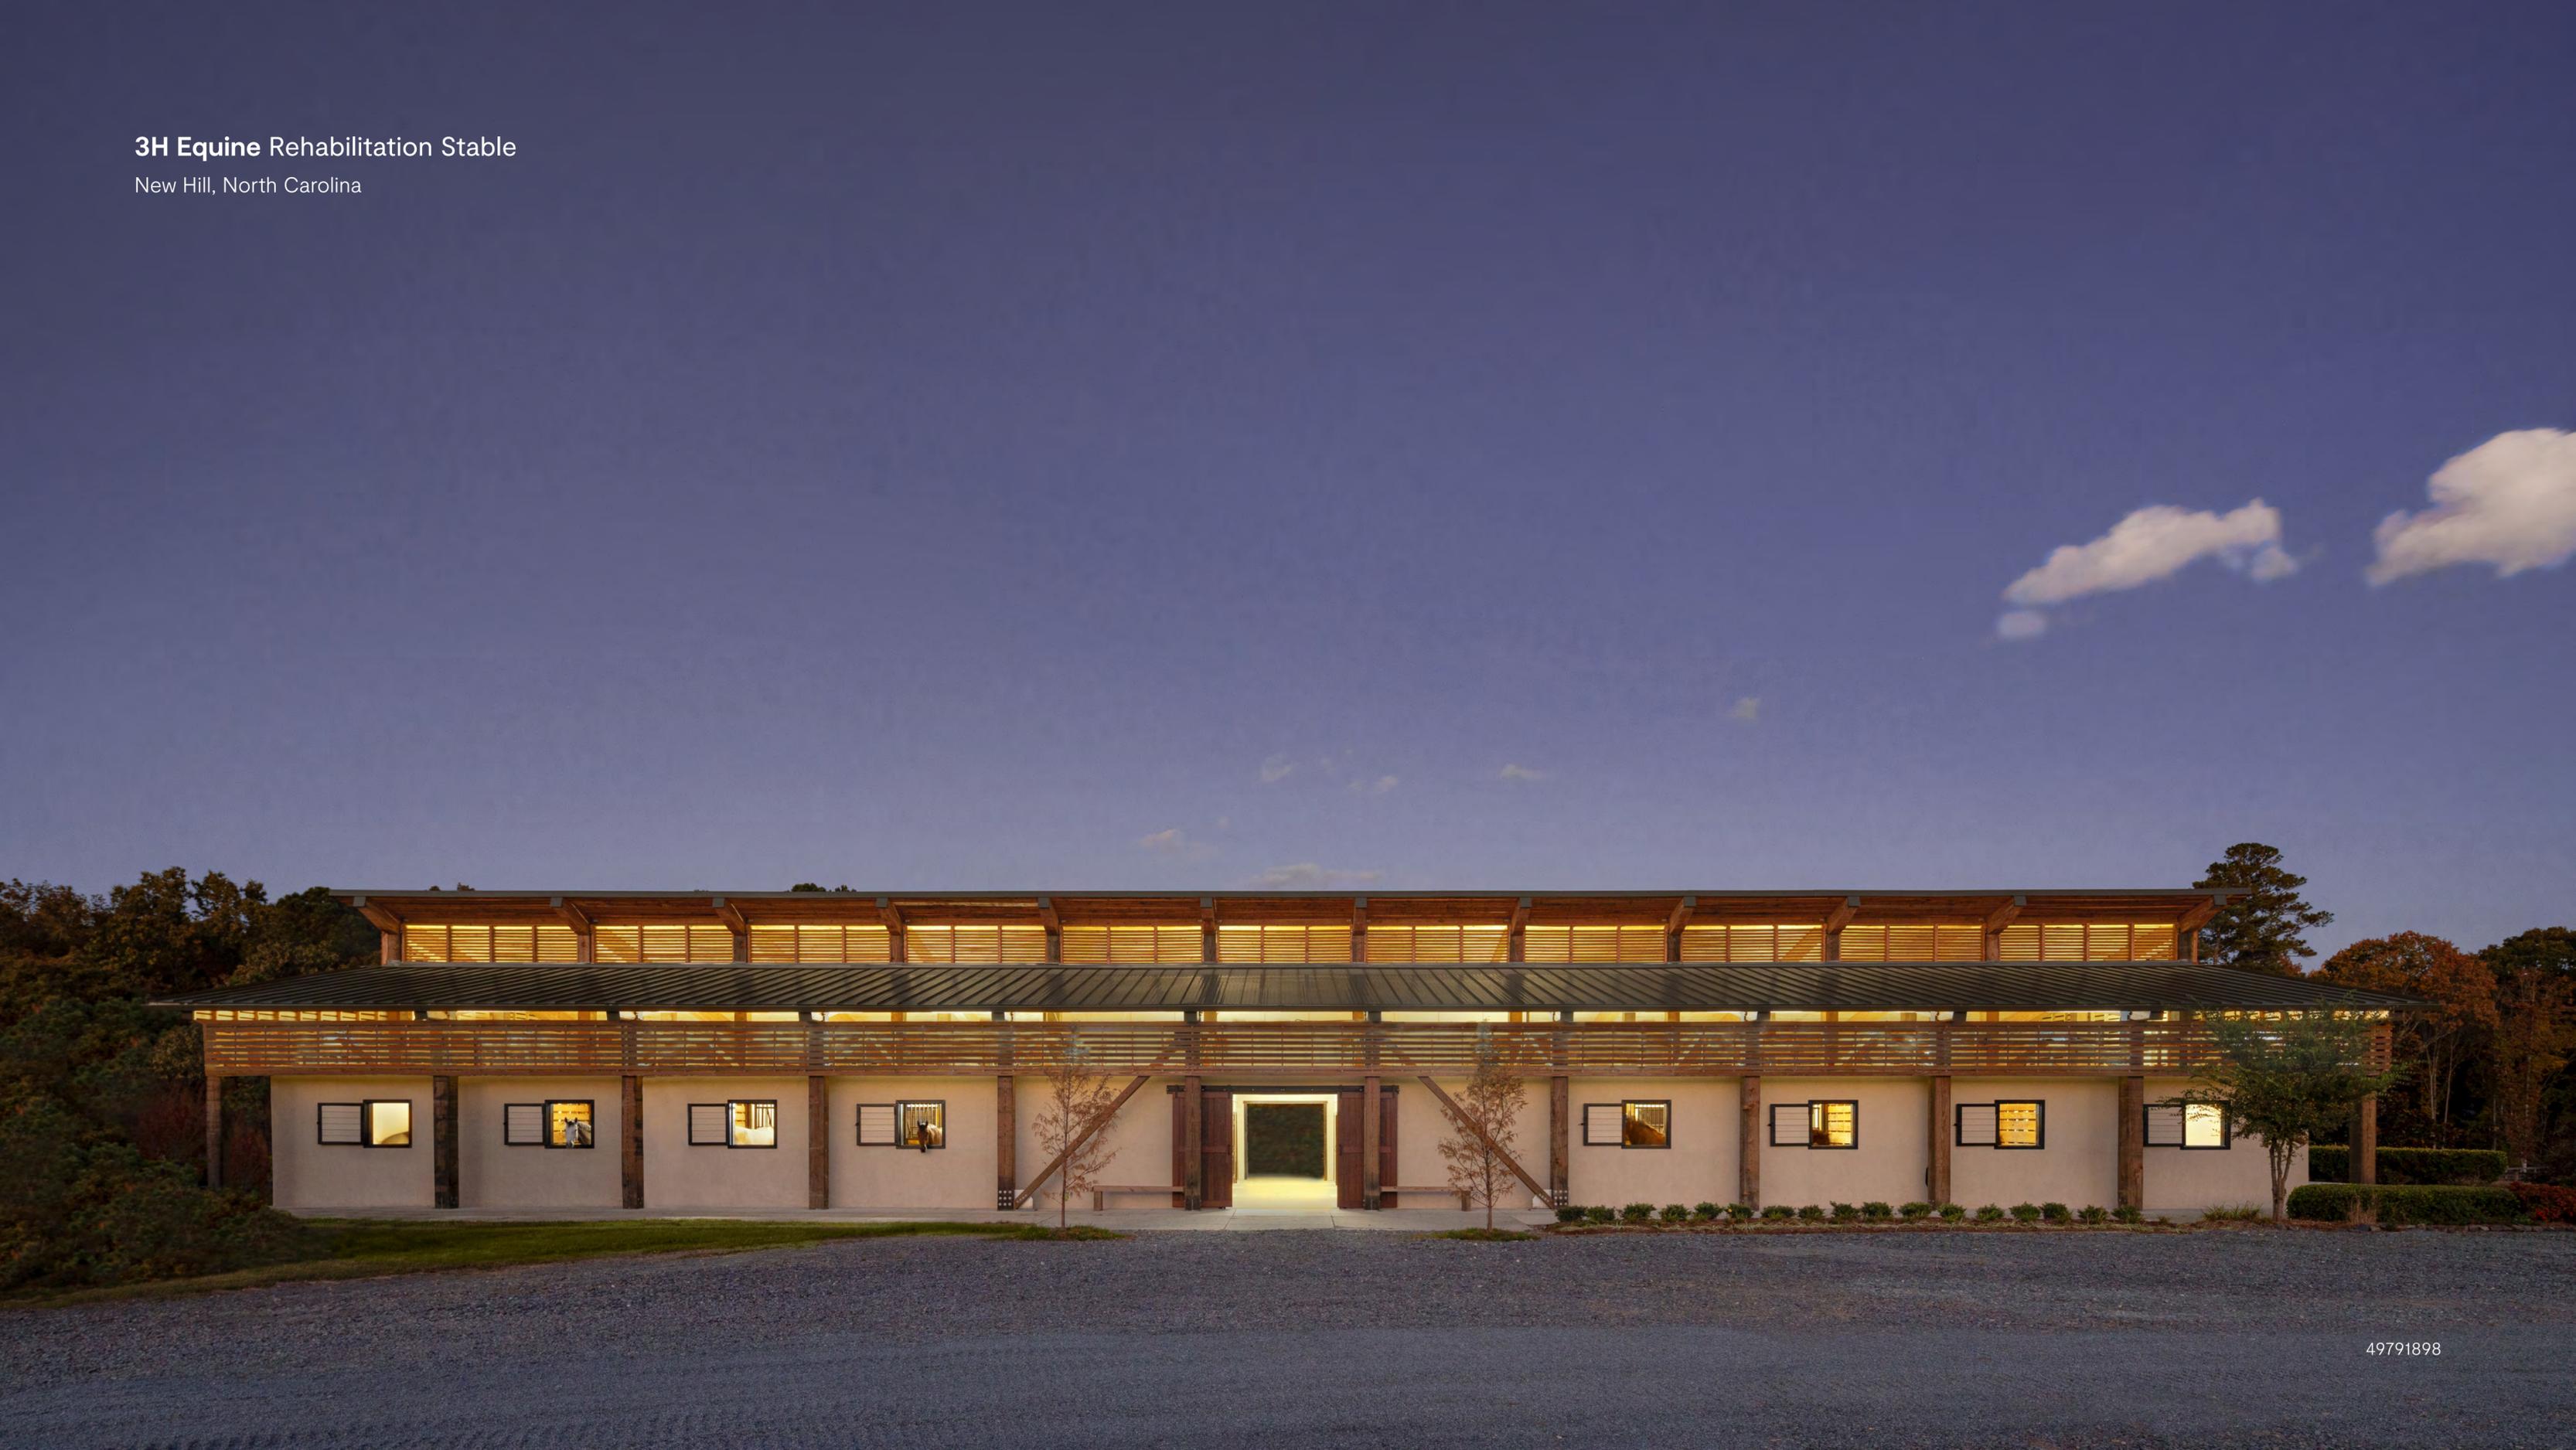
- 1 Rehabilitation Stable
- 2 Pasture
- 3 Clients Home
- 4 Admin
- 5 Competition Track
- 6 Stalls
- 7 Covered Storage

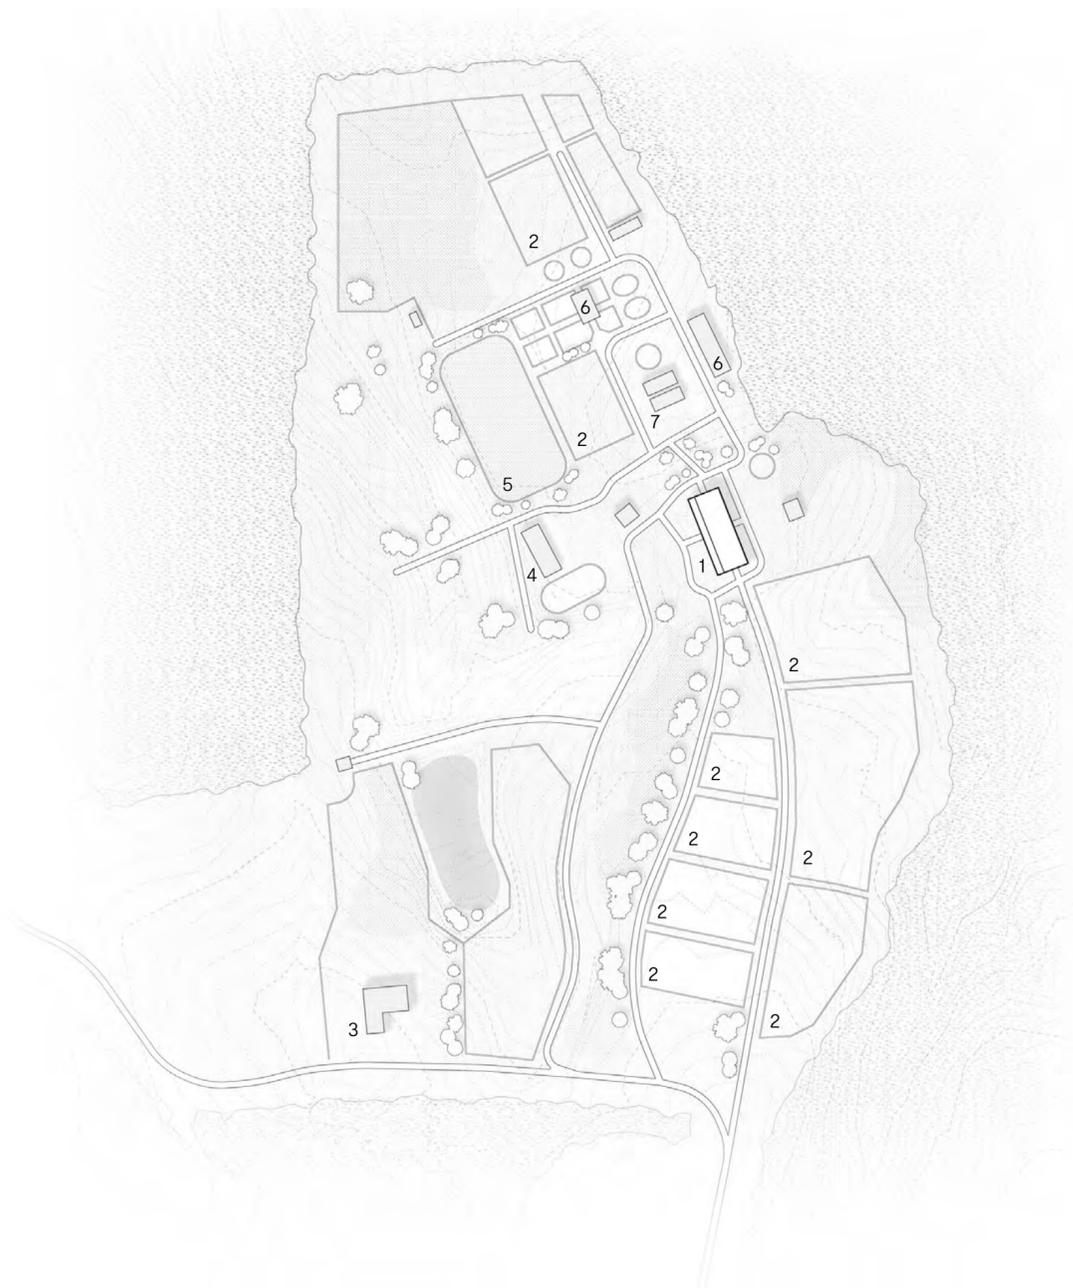
Existing Site Conditions

The 3H Equine Rehabilitation Stable is an adaptive-reuse of our clients former veterinary clinic. A fire caused from hay chaff build up and inadequate air circulation, left only ground level concrete walls. It became imperative for our client and the design team to memorialize the history of the clinic through the reclamation of these walls in the new facility.

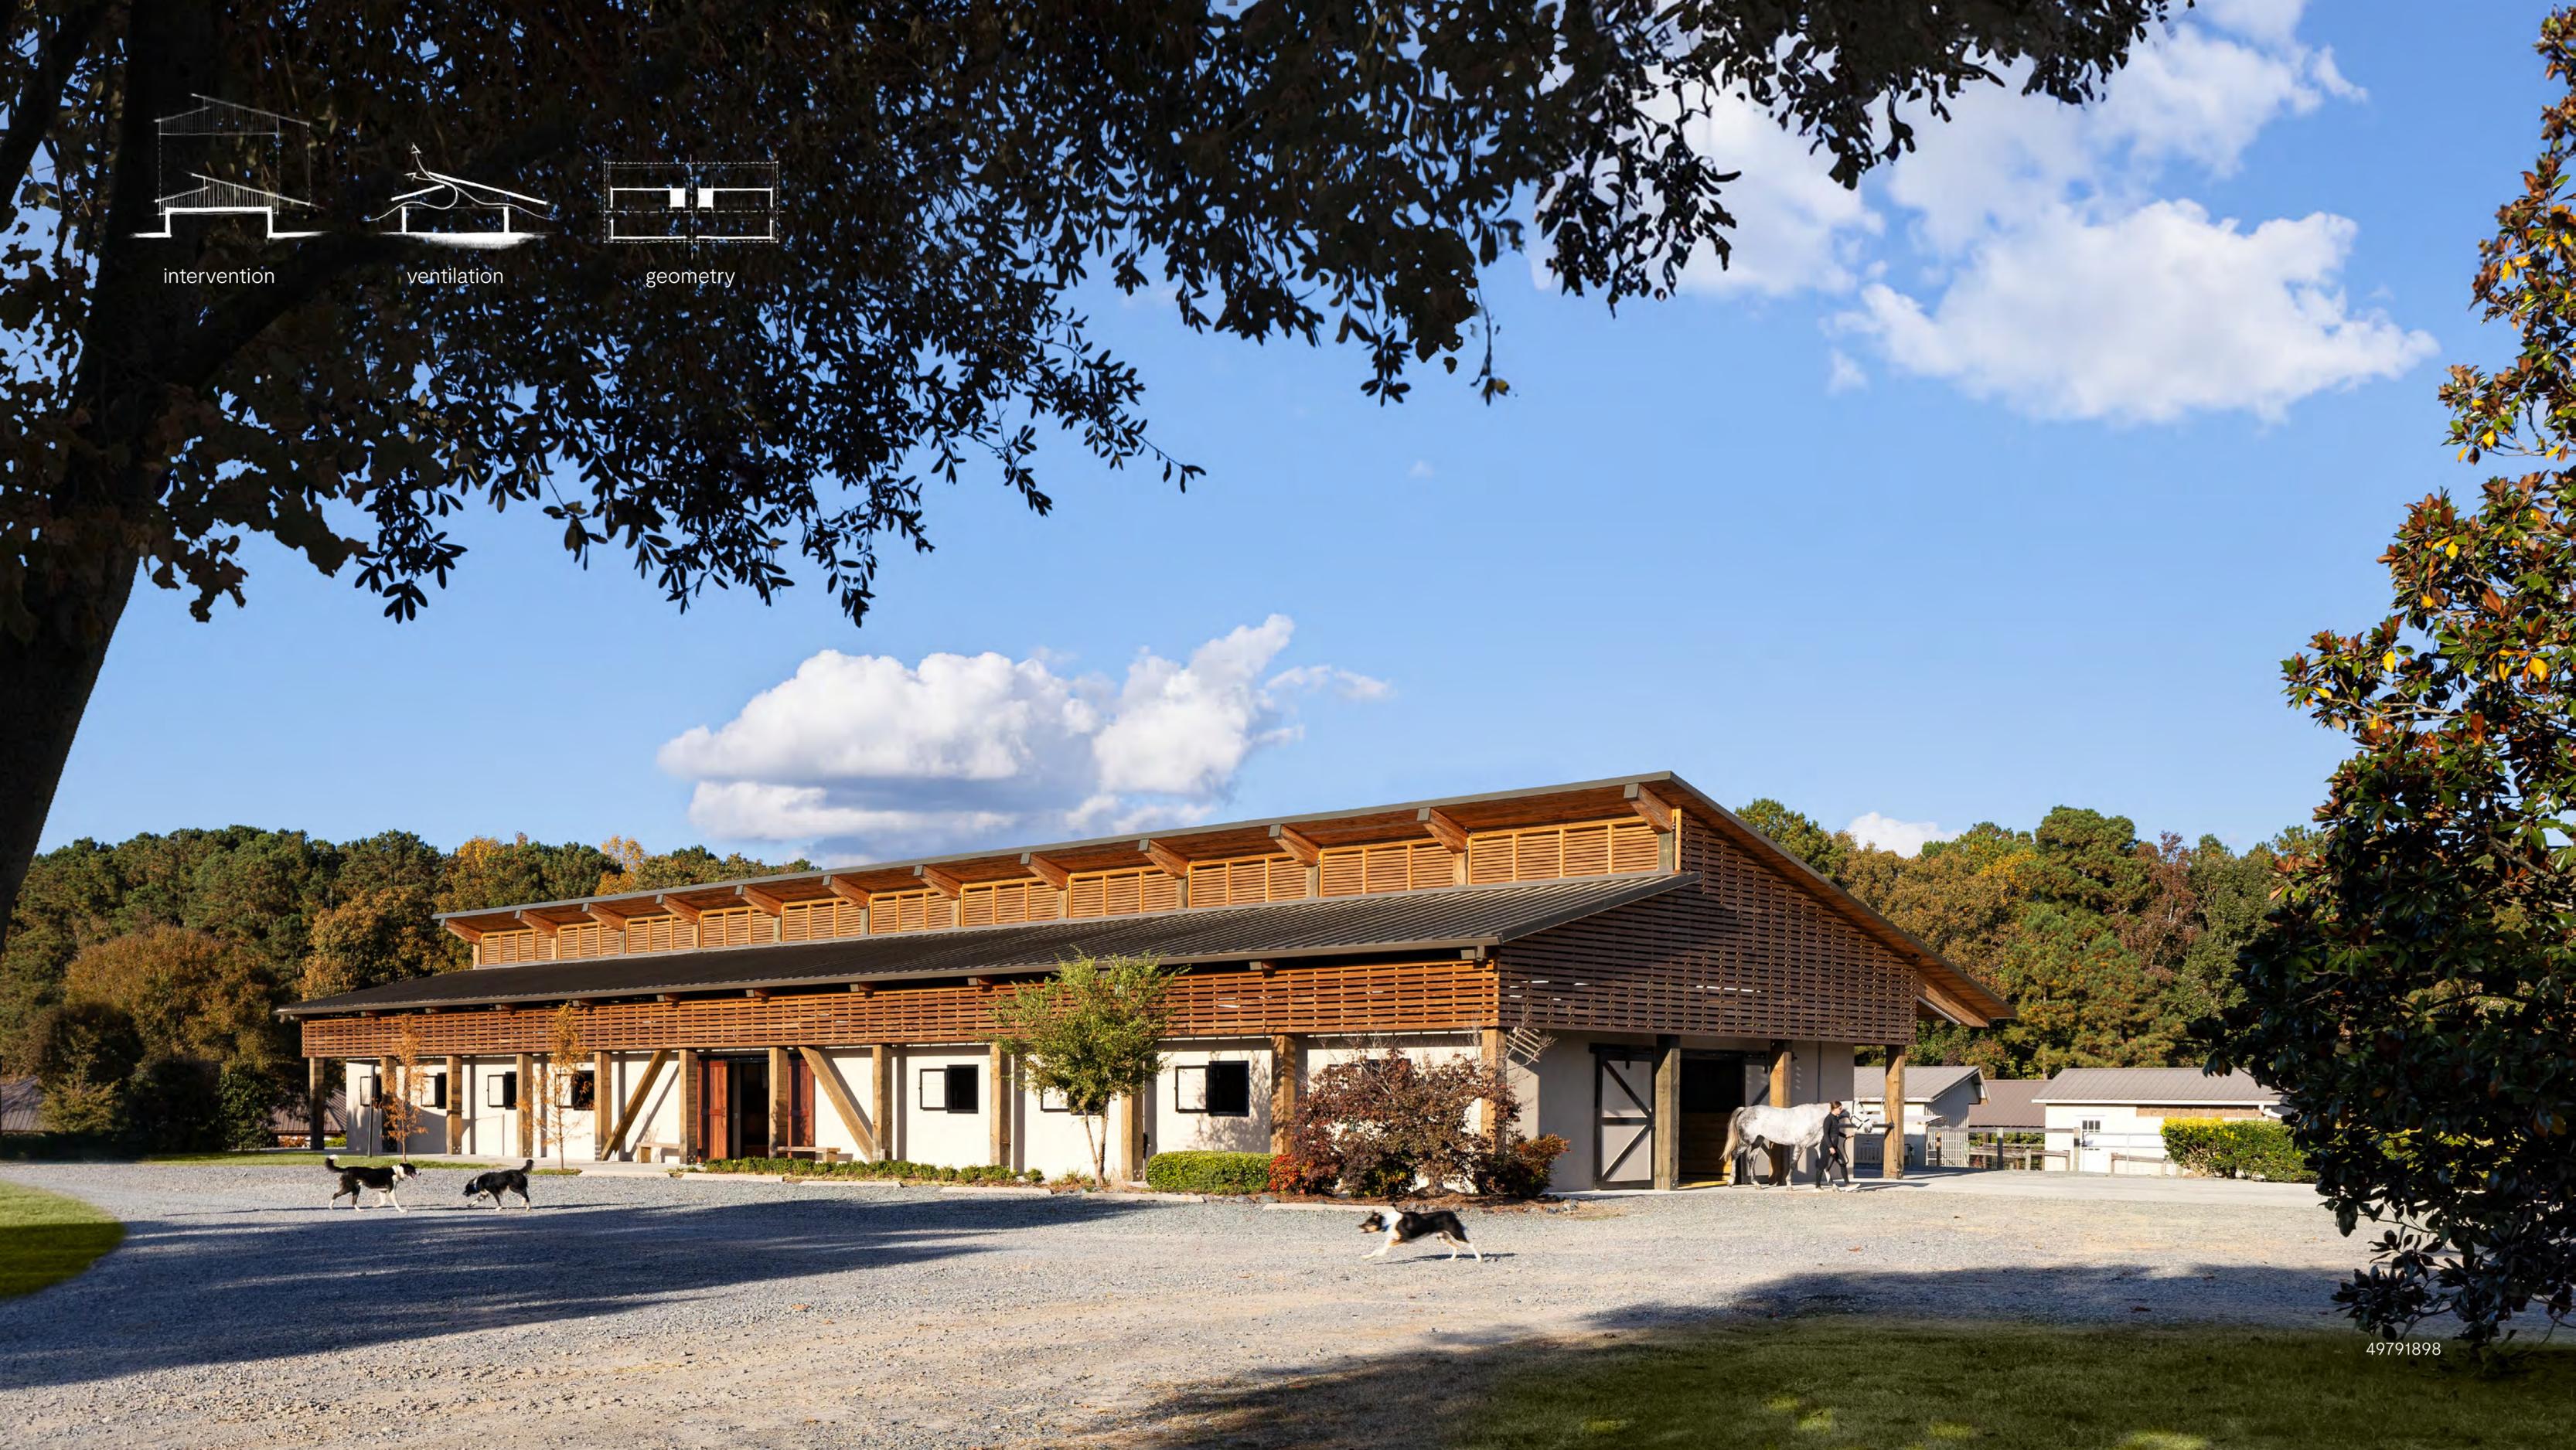
- 1 Stalls
- 2 Treatment/ Wash Bay
- 3 Tack Room
- 4 Toilet
- 5 Laundry
- 6 Feed
- 7 Storage
- 8 Ship Ladder (Access to Loft)
- 9 Aisle
- 10 Covered Workspace

The timber intervention straddles the existing walls and is organized around the proportions of a horse stall. The regular grid of columns creates a central aisle accommodating safe movement animals and their handlers and ties into broader campus paths.

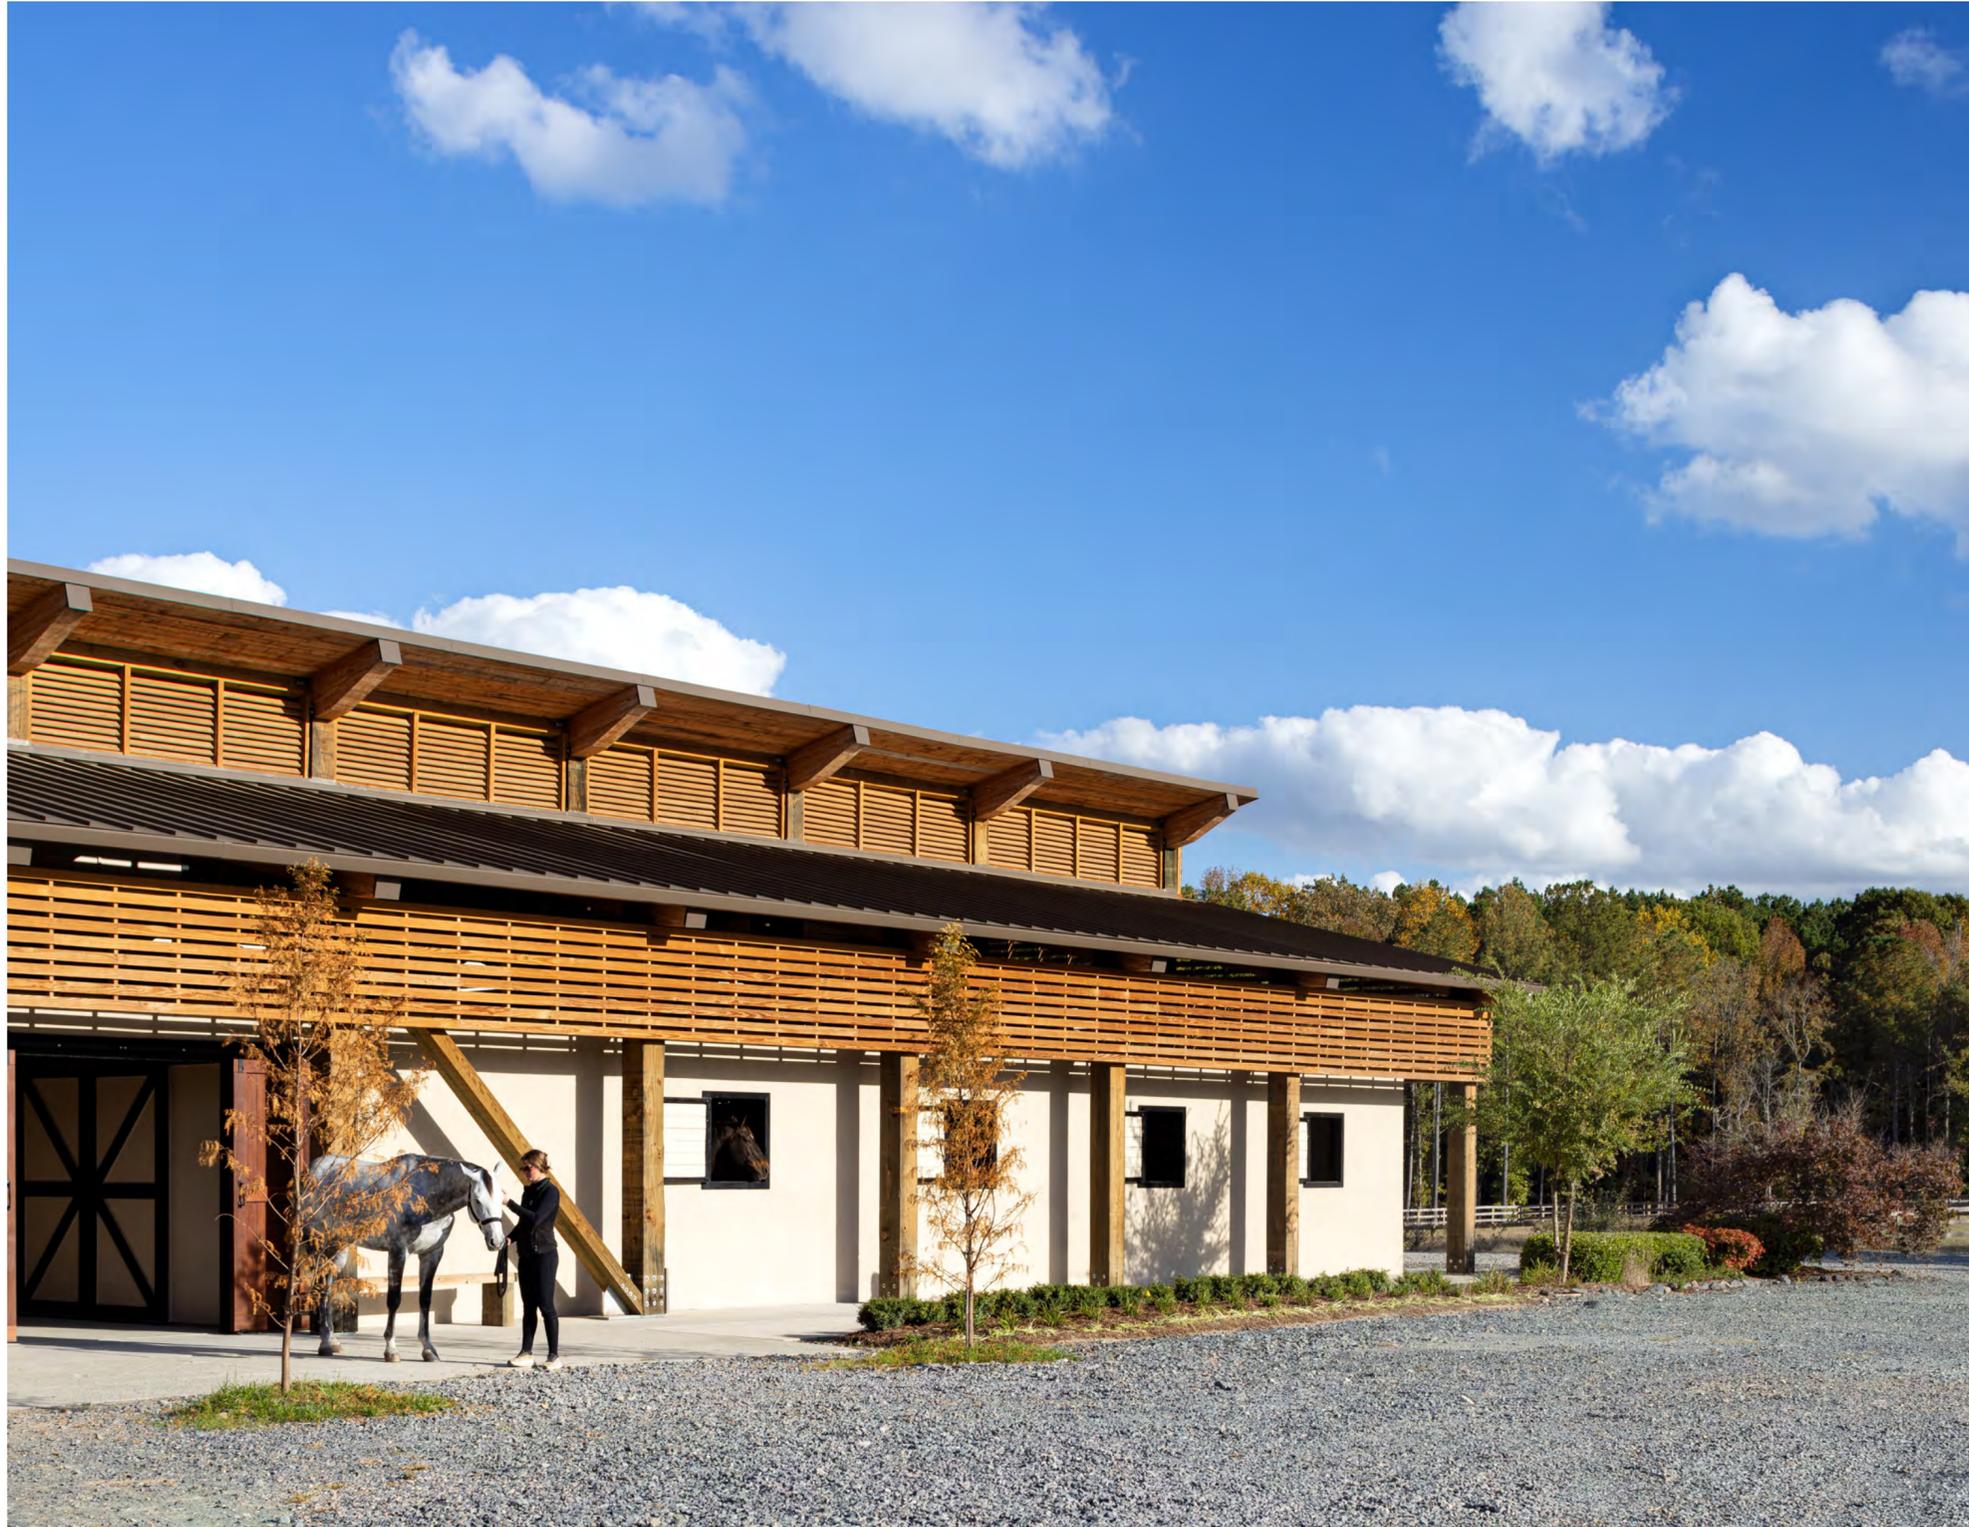
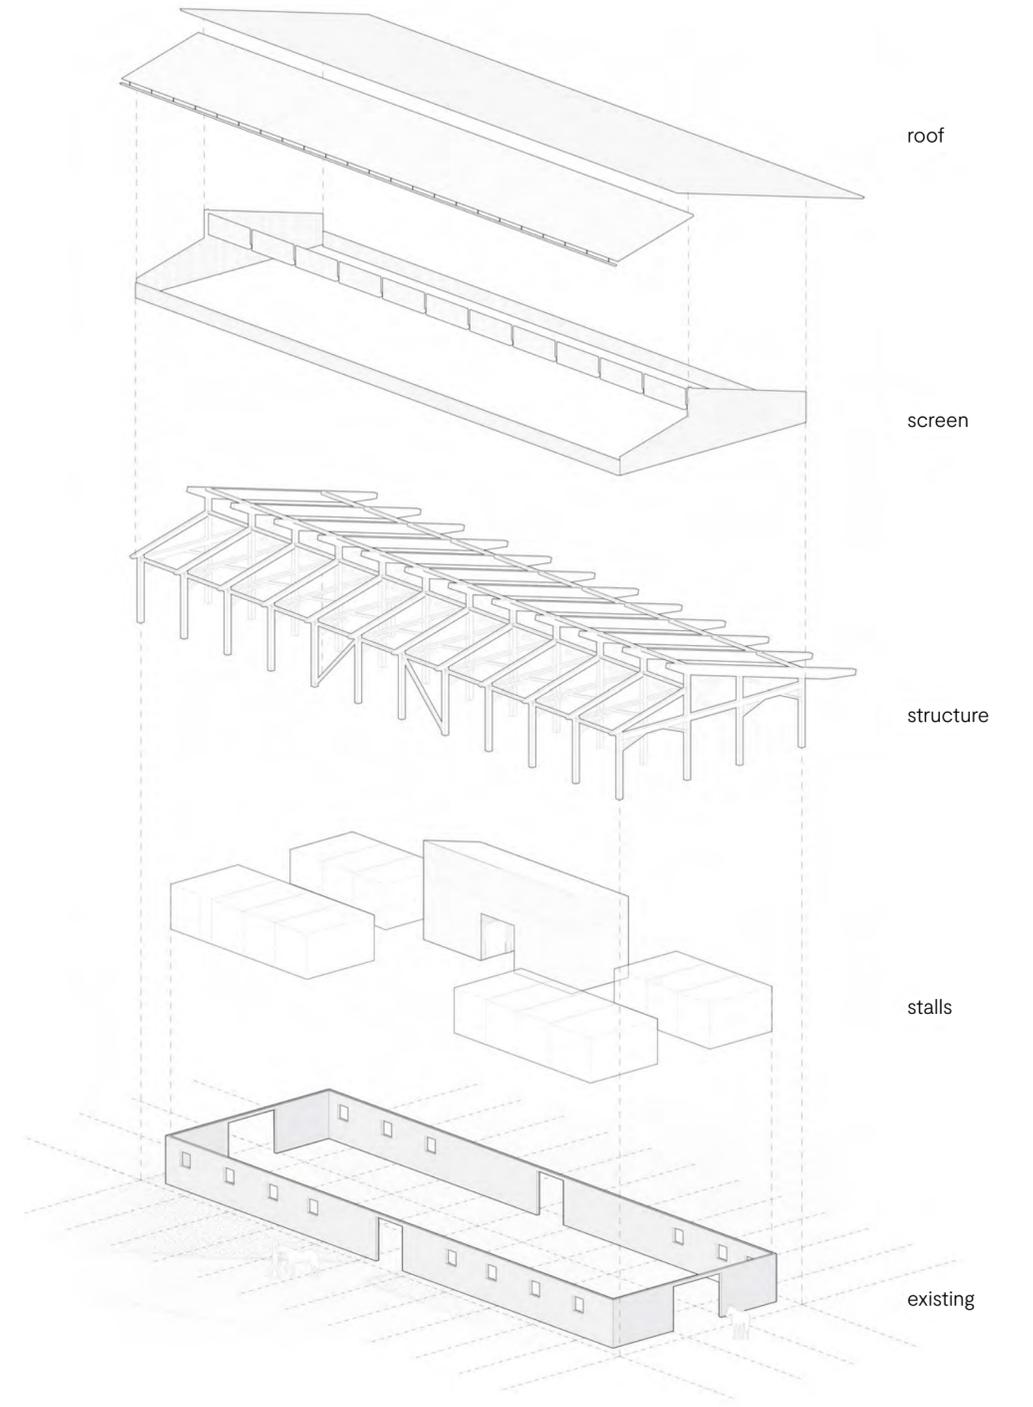
Organization and Program

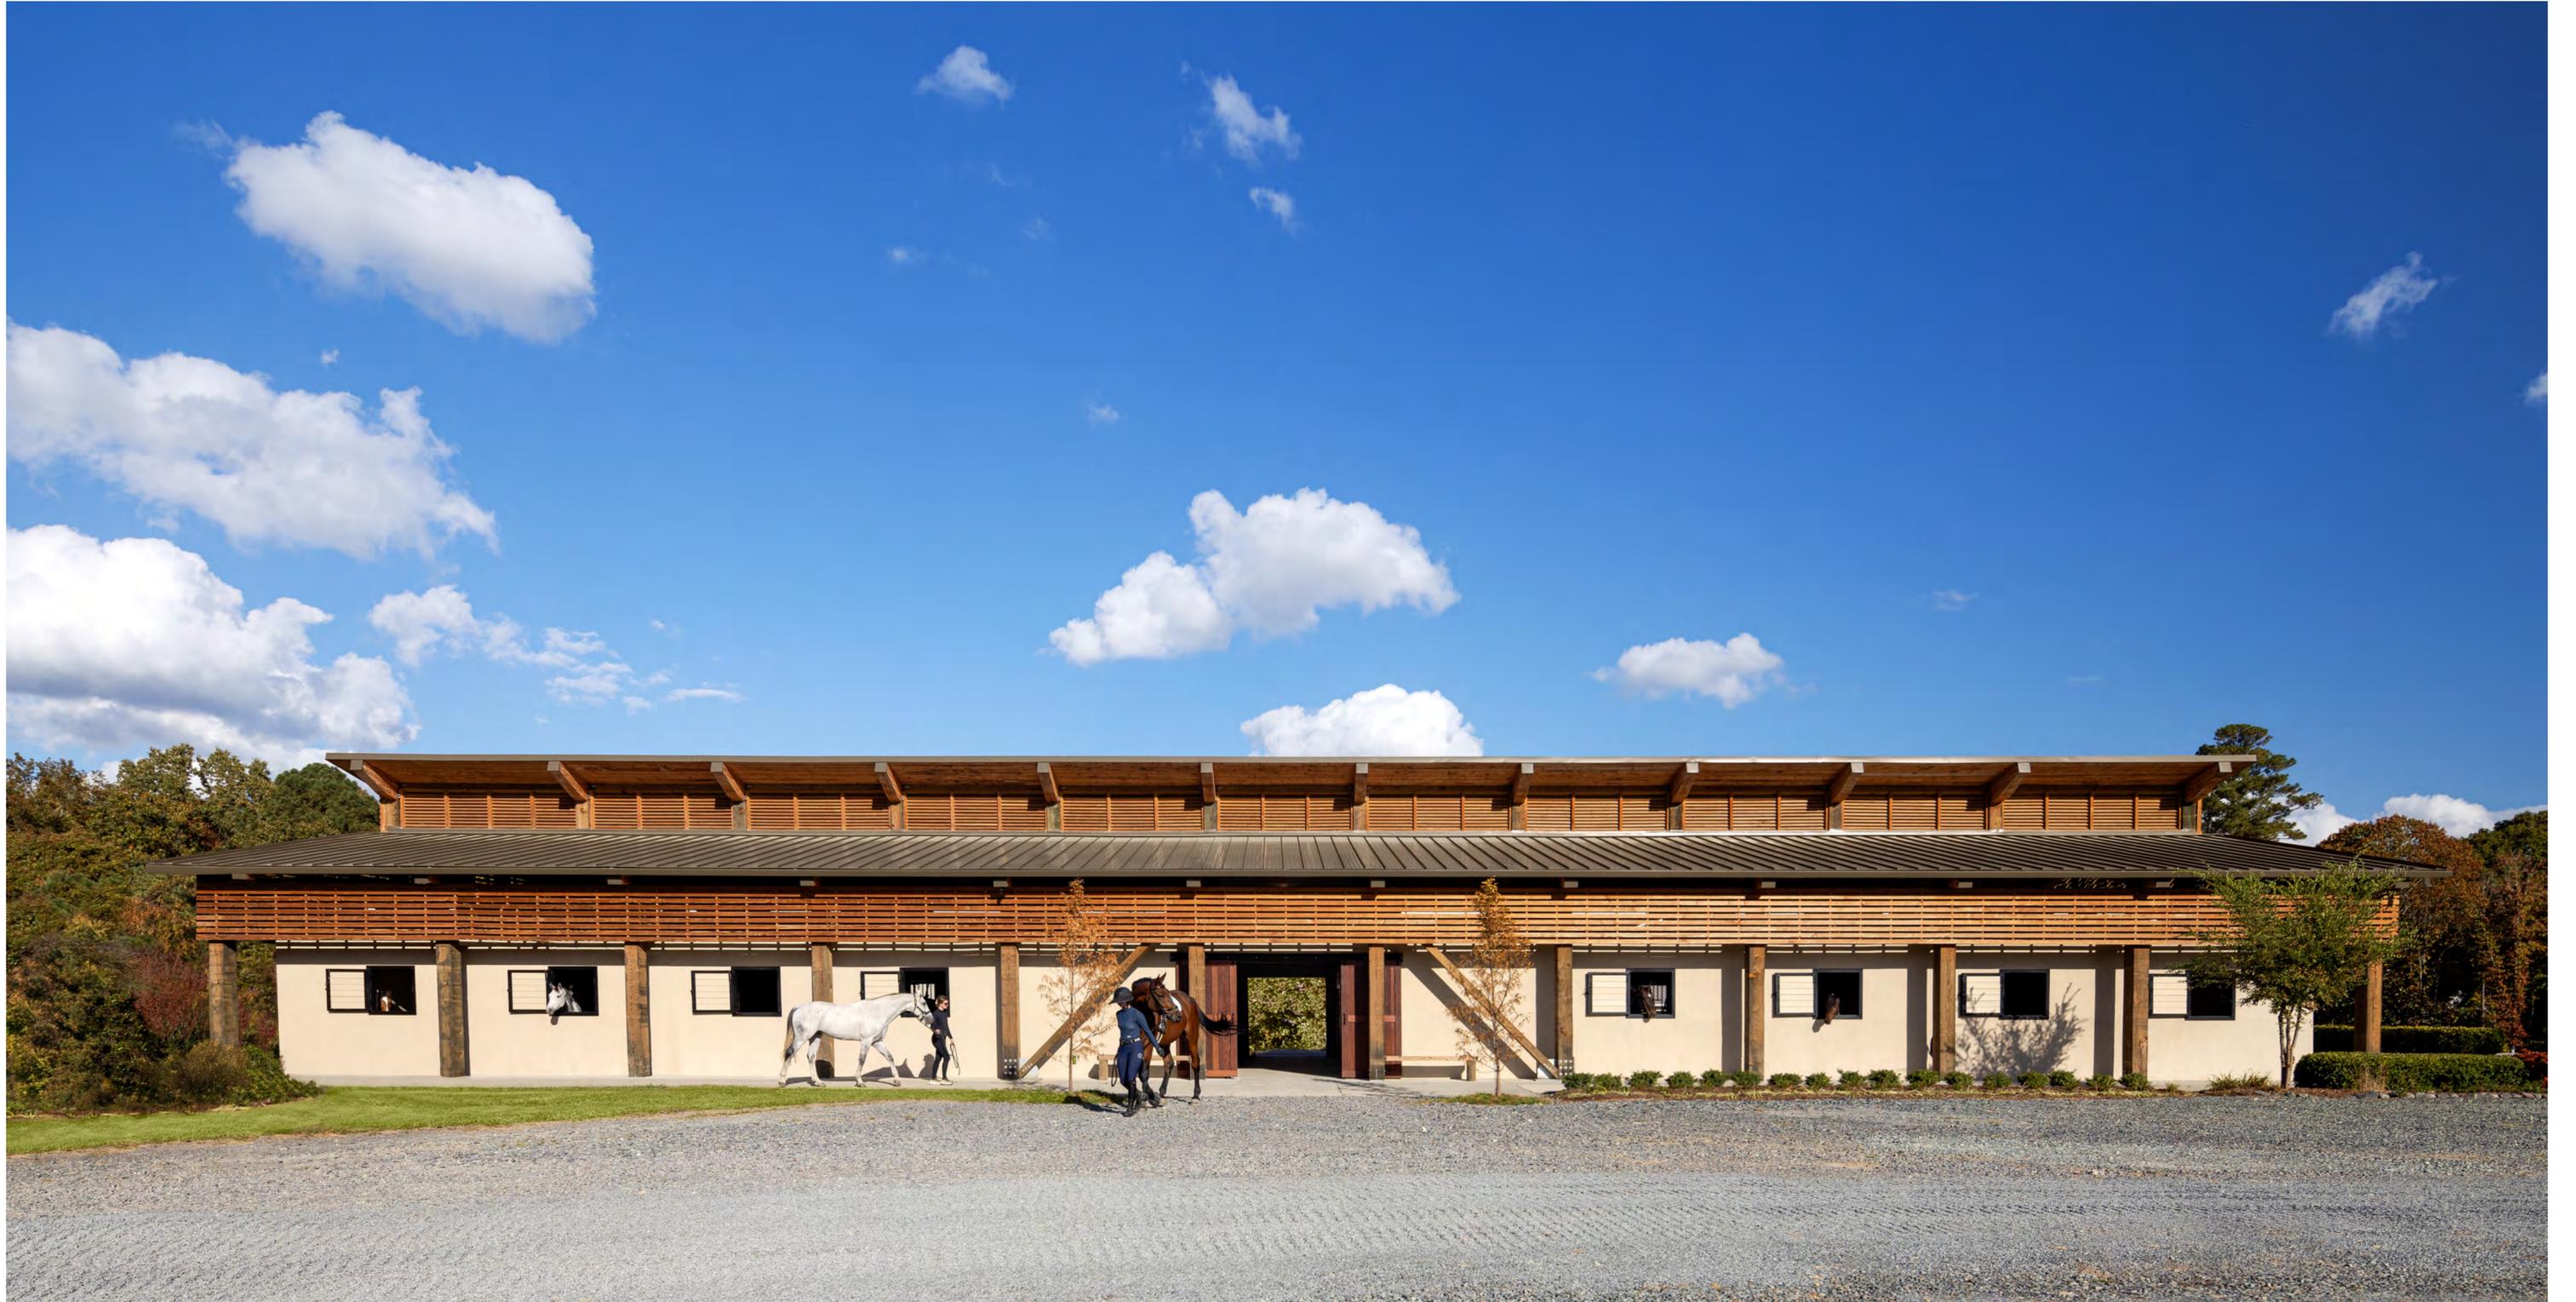
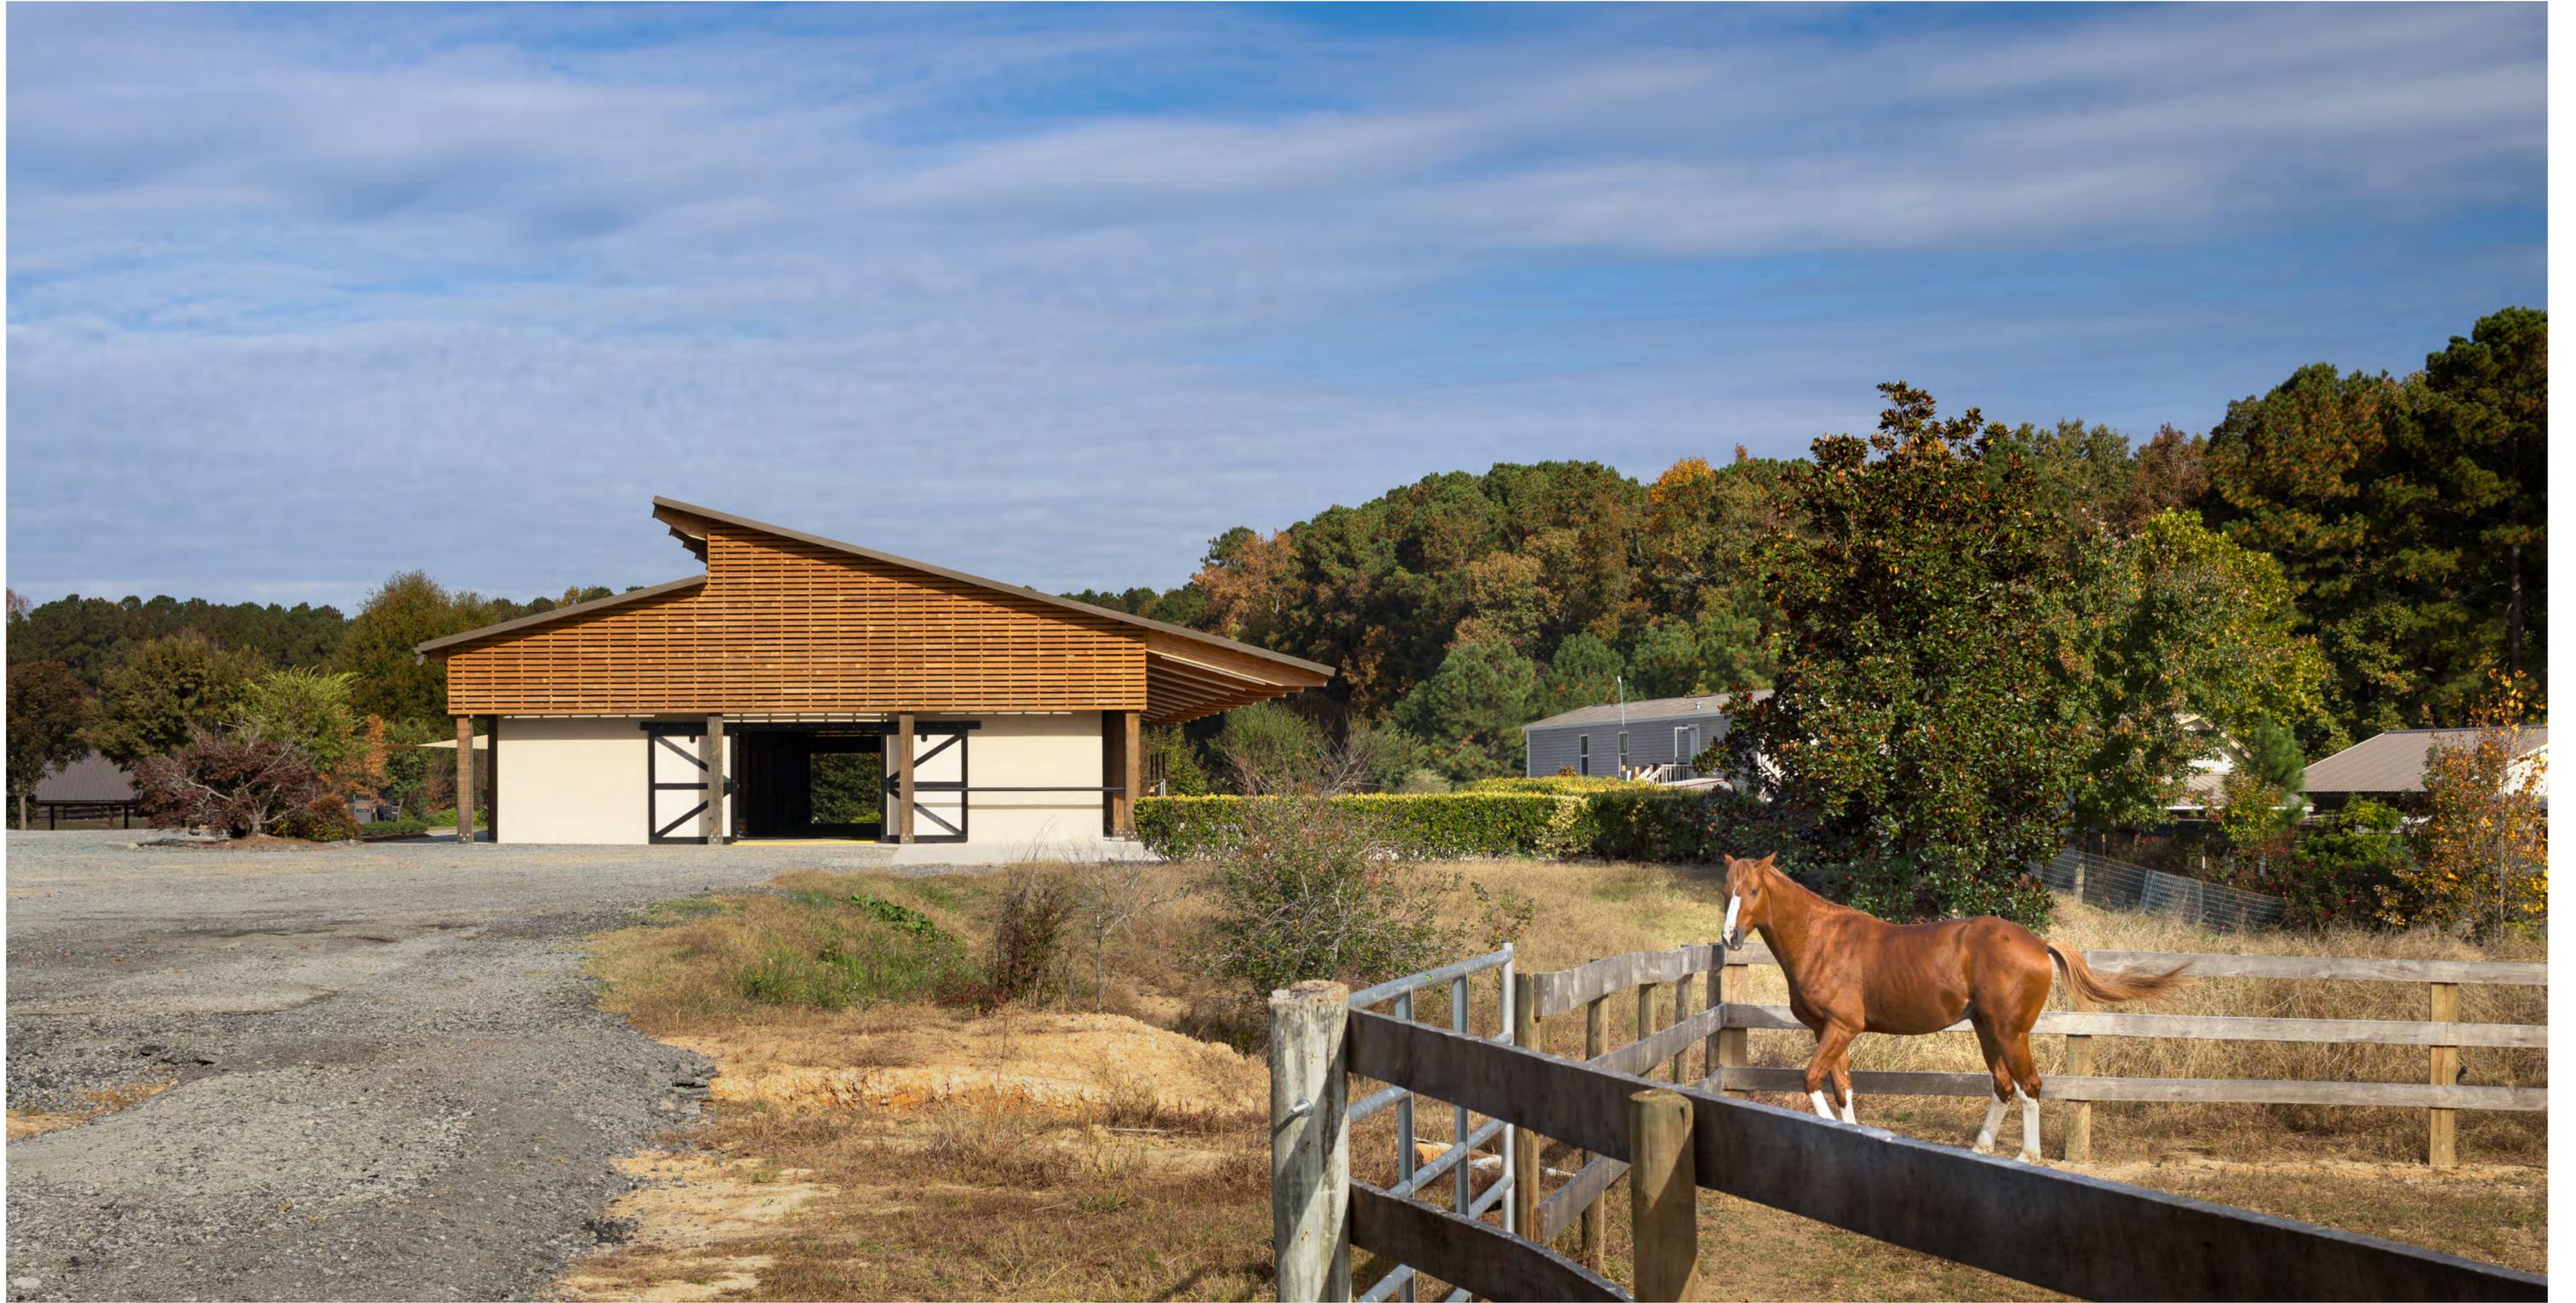
Section | Stalls and Covered Workspace

ventilation

stalls

aisle

covered workspace

Cantilevered eaves on the east elevation provide shade for working stable hands and clearance access for farrier trucks.
