3H Equine Rehabilitation Stable

New Hill, North Carolina

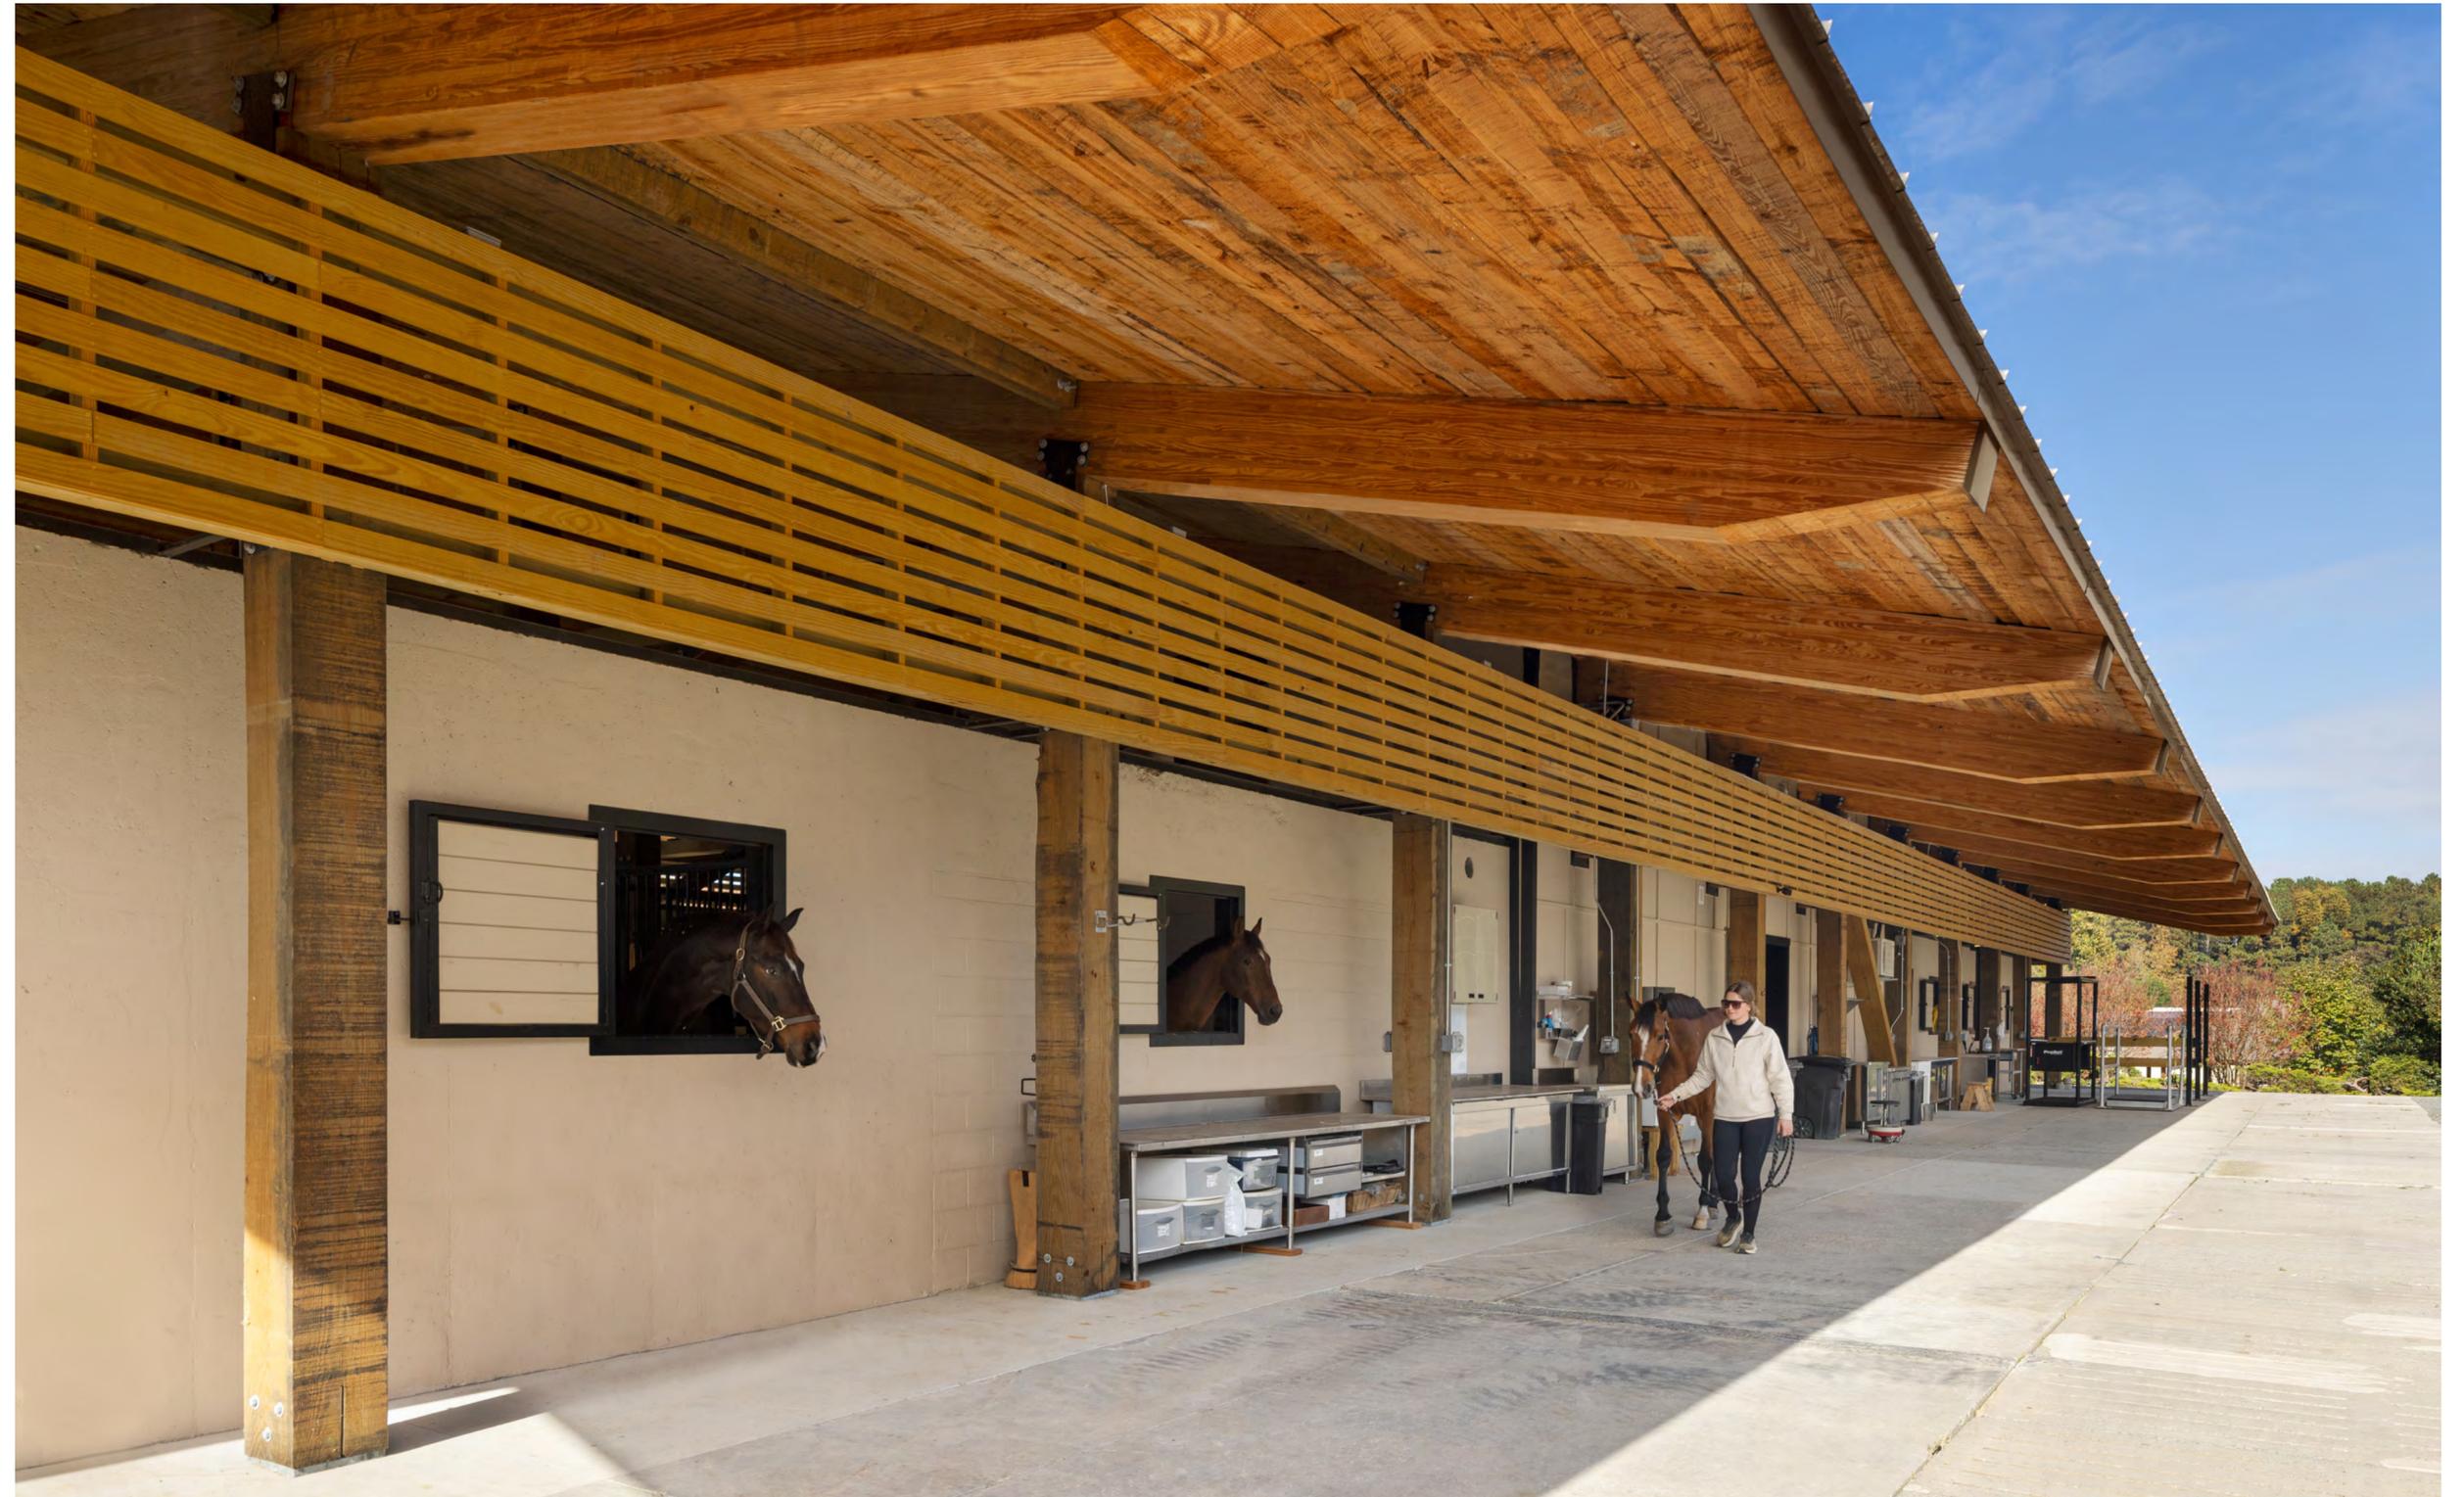
Functionality

Cantilevered eaves on the east elevation provide shade for working stable hands and clearance access for farrier trucks.

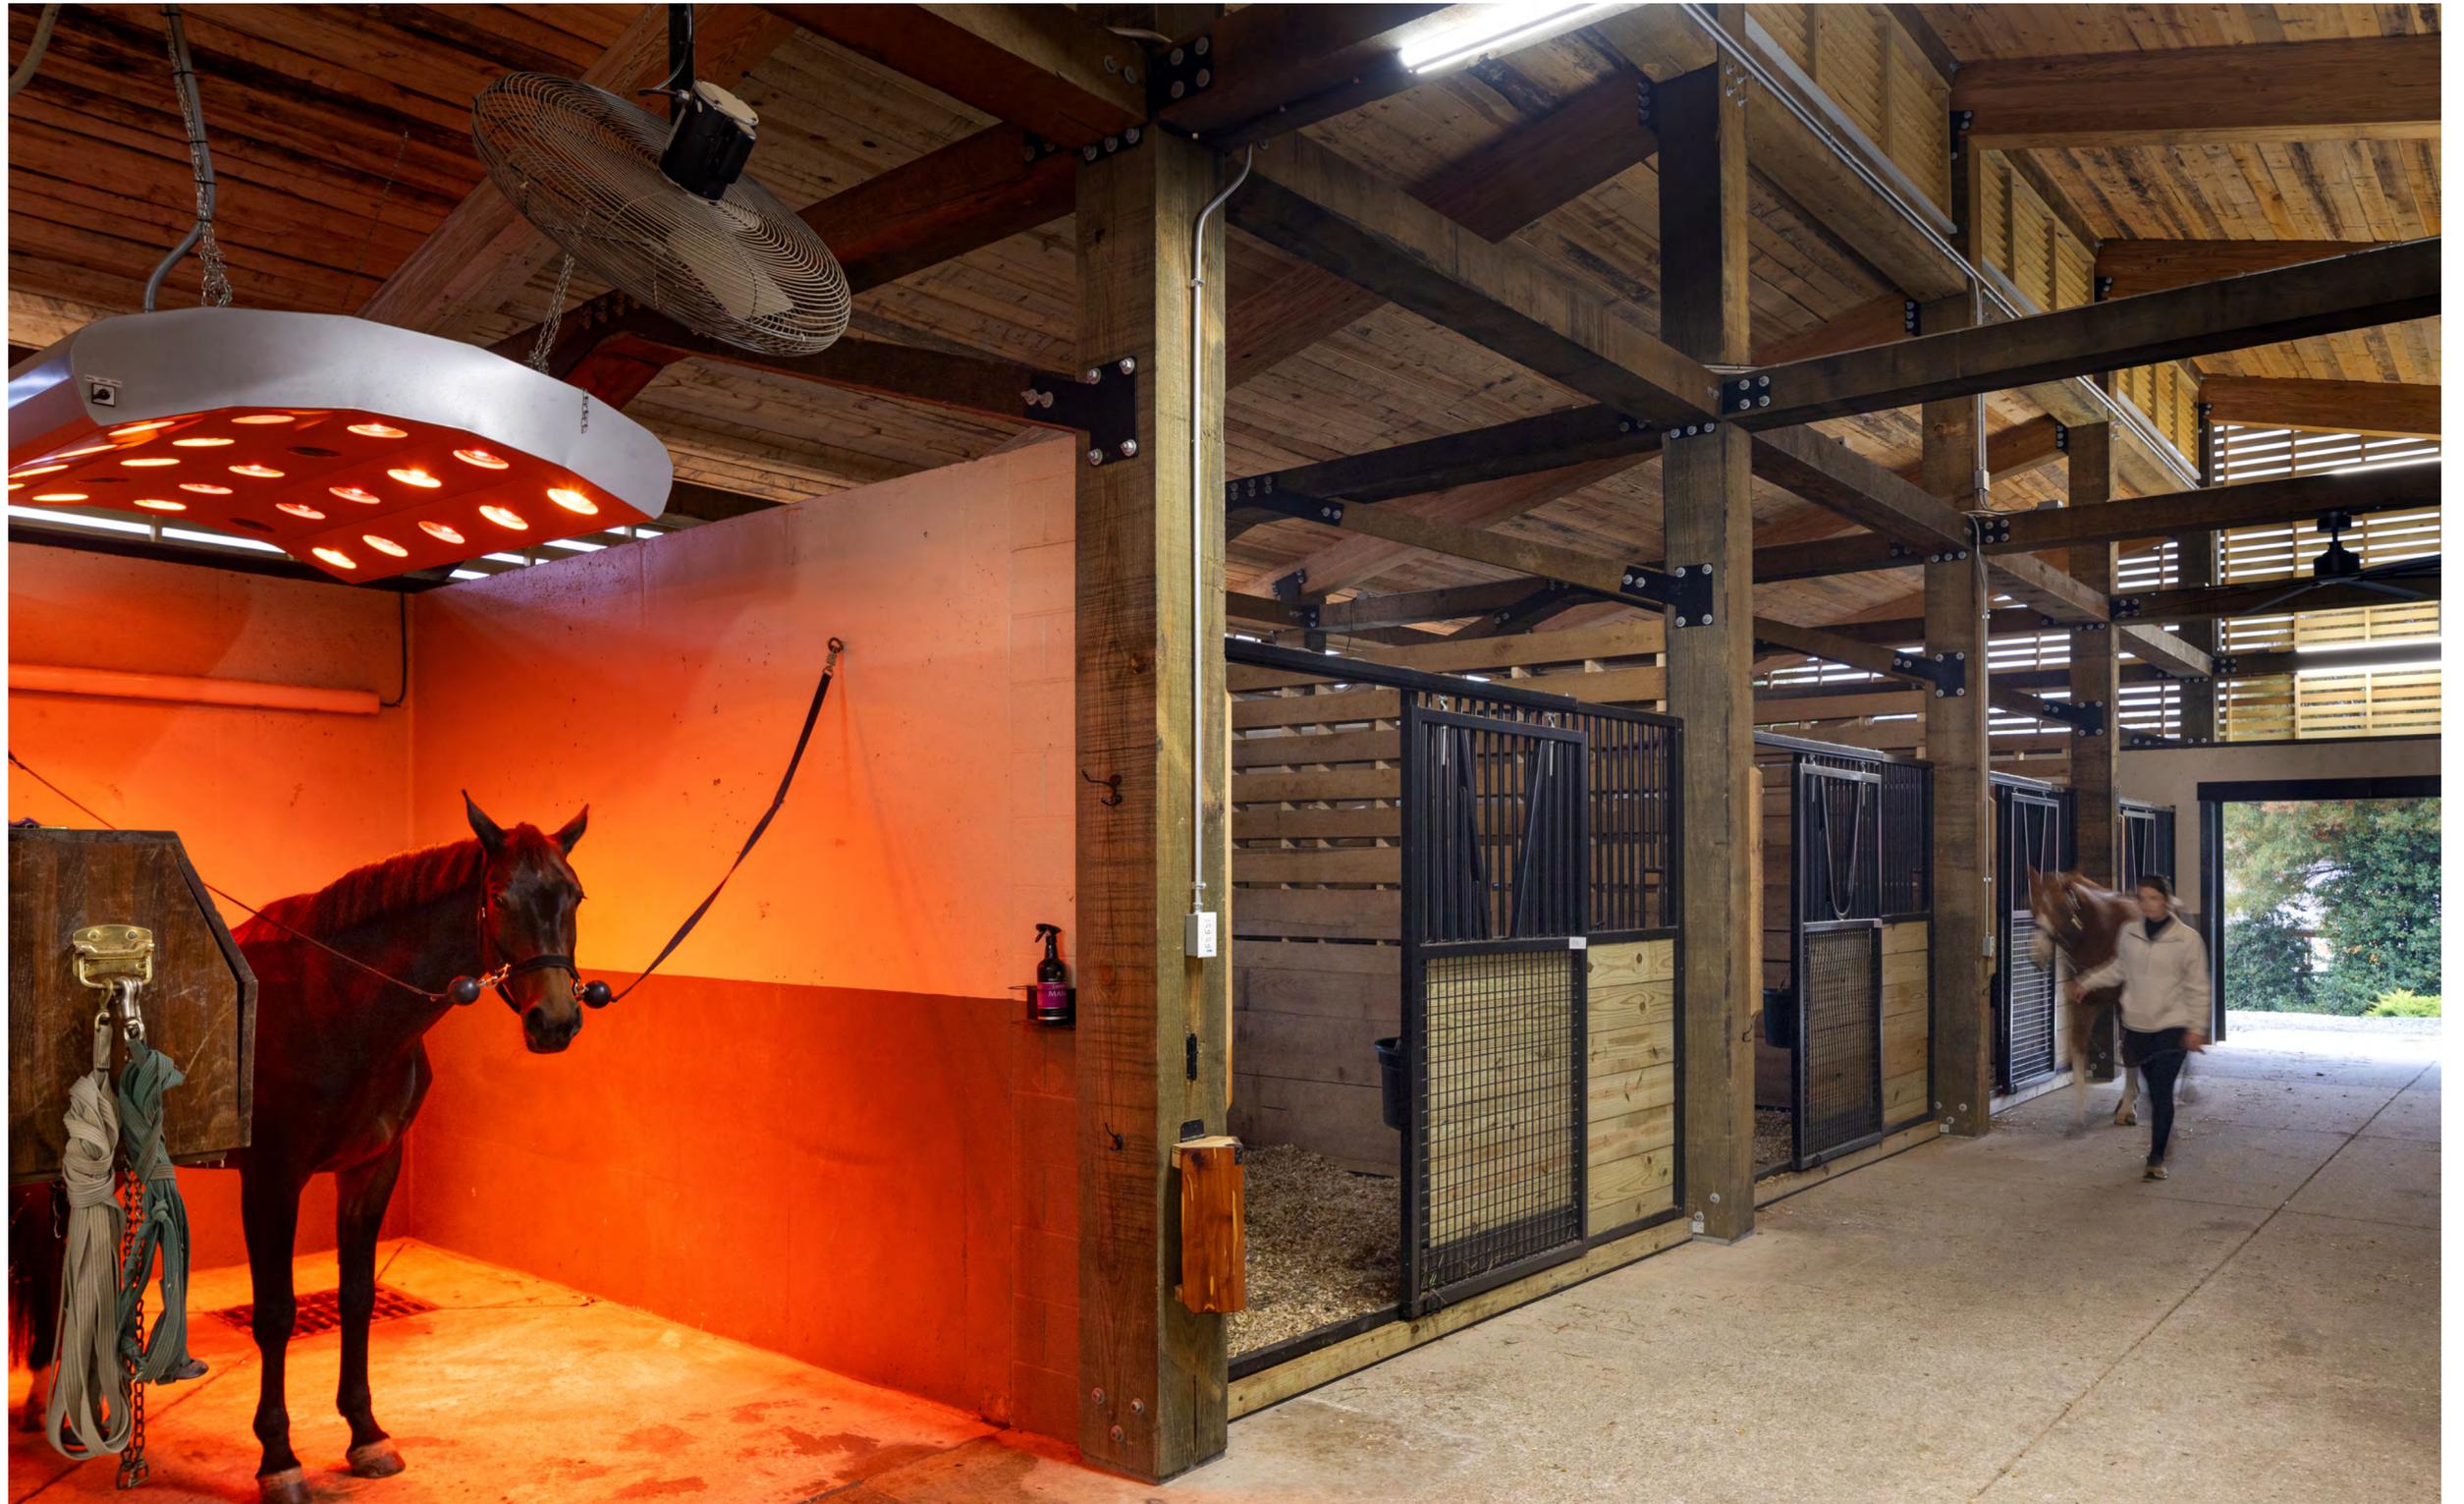
Program

Stalls, treatment/wash bays, and tack rooms line the central aisle, offering framed views of the site.
